**Flood Control Project Maintenance
Levee Inspections**

Fall 2011 Levee Maintenance Deficiency Summary Report

Reclamation District No. 0003 Grand Island

Levee Inspection Report By Mile - Fall 2011

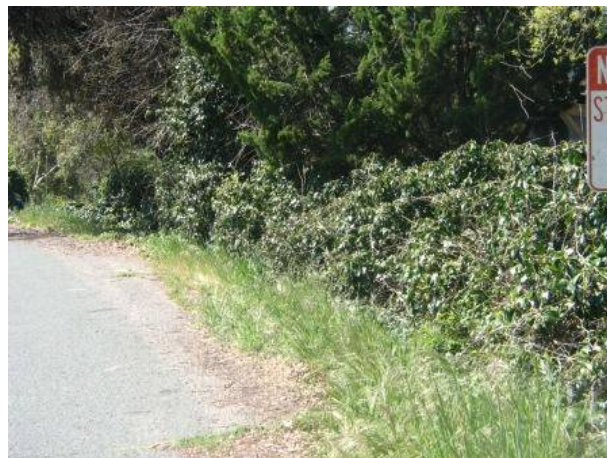
Levee Mile Report Line	2
Start Levee Mile	0.22
End Levee Mile	0.33
Location	Water Side
Category	Earthen Levee
Item	Encroachments

Dense landscaping on waterside from LM 0.22 to 0.28

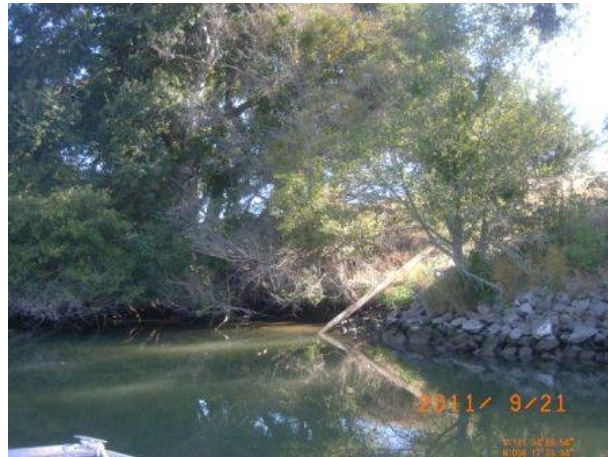
Levee Mile Report Line	5
Start Levee Mile	0.92
End Levee Mile	0.97
Location	Water Side
Category	Supplemental
Item	USACE Erosion Survey

5	0.92	0.97	Supplemental	USACE Erosion Survey	WS	M	Inspector Comments: 1997 - Erosion of sandy levee on top left bank. Site is downstream of a rock section. Large riparian trees on the bank. 1999 - Upstream half of the reach repaired with rock, except for a 30 ft reach at the upstream end. 2001 - Rock repair on the upstream and downstream ends; no revetment at the trees. 2002 - Rock repair is starting to slide off the geotextile at the upstream end. 2005 - One new small tree has fallen. 2006 - 50 ft pocket at the downstream end and at the upstream end with new rock in between. 2007 - Upstream end has been repaired. 2010 - Some minor new erosion. 2011: Minor new erosion. [2011 Site ID: STM_25-0_L]	38.293386 ° -121.582554 °	38.292675 ° -121.582741 °	10 Y
6	0.94	1.14	Supplemental	USACE Erosion Survey	WS	M	Inspector Comments: 2008 - Area closed sign on bank. Newly fallen trees at both ends and pop outs along the bank. 2010 - Site extended downstream. 2011: New erosion at the toe. More trees popouts. [2011 Site ID: STM_24-8_L]	38.291695 ° -121.582993 °	38.289575 ° -121.583092 °	14 Y

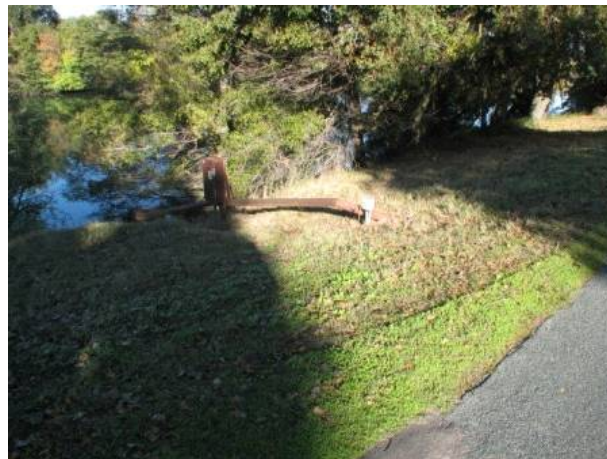
Levee Mile Report Line	7
Start Levee Mile	0.97
End Levee Mile	0.97
Location	Crown
Category	Earthen Levee
Item	Encroachments

Irrigation intake pipe from Steamboat Slough.

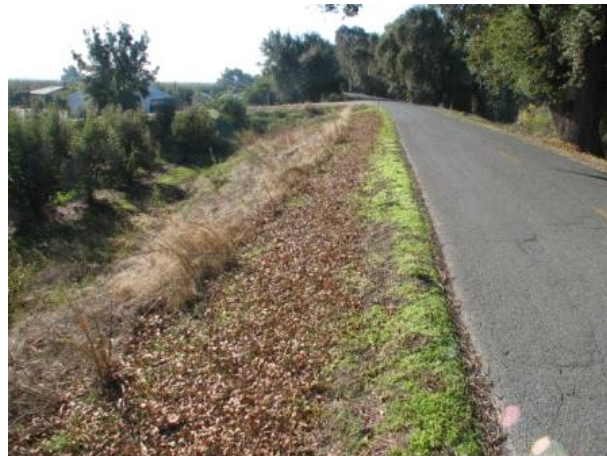
Levee Mile Report Line	8
Start Levee Mile	1.01
End Levee Mile	1.03
Location	Land Side
Category	Earthen Levee
Item	Vegetation

Grass on levee slope and toe exceeds 12" and partially obstructs visibility.

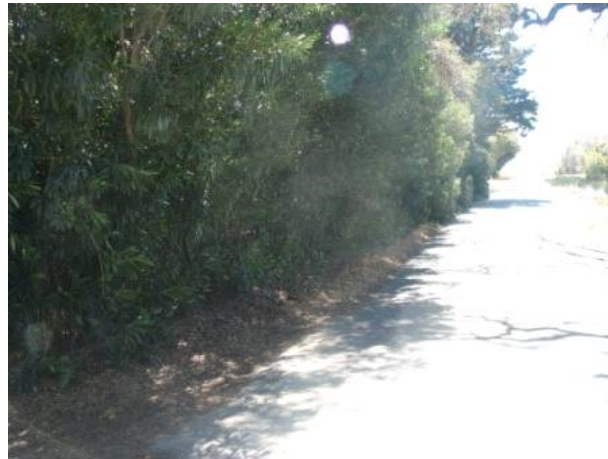
Levee Mile Report Line	10
Start Levee Mile	1.21
End Levee Mile	1.27
Location	Land Side
Category	Earthen Levee
Item	Encroachments

Landscaping on landside slope block view of levee from LM 1.21 to 1.27

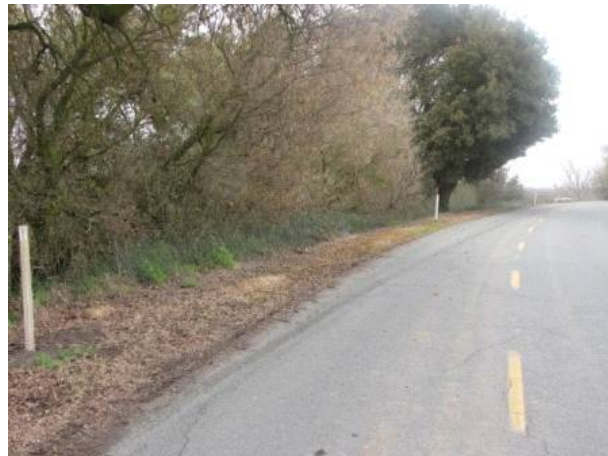
Levee Mile Report Line	11
Start Levee Mile	1.28
End Levee Mile	1.33
Location	Land Side
Category	Earthen Levee
Item	Trim / Thin Trees

Looking northeast at dense vegetation on waterside slope.

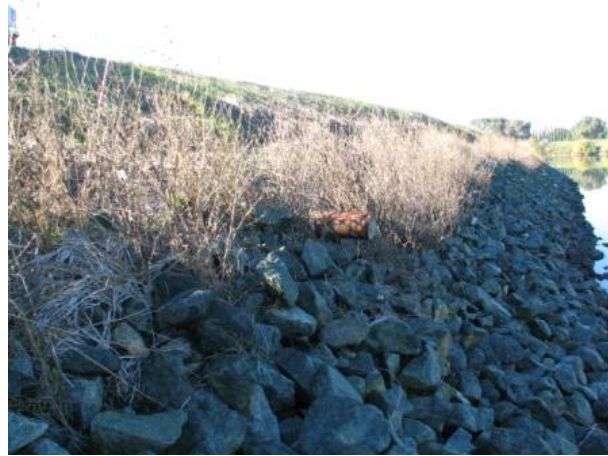
Levee Mile Report Line	35
Start Levee Mile	3.52
End Levee Mile	3.52
Location	Crown
Category	Earthen Levee
Item	Encroachments
Abandoned pipe penetration. Pipe has been grouted.	
richard_f_20111014_976.jpg

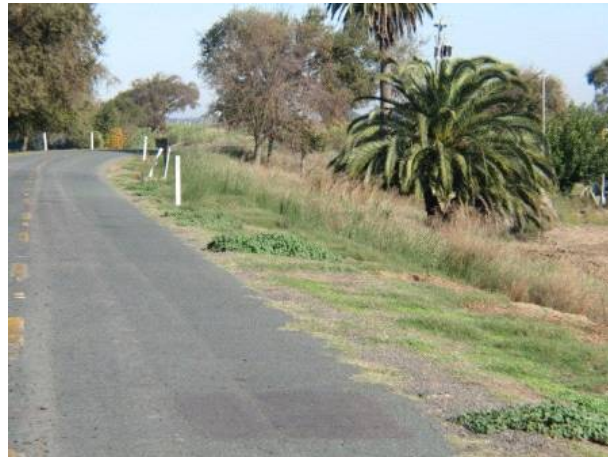
Levee Mile Report Line	42
Start Levee Mile	4.30
End Levee Mile	4.49
Location	Land Side
Category	Earthen Levee
Item	Vegetation
Vegetation on levee slopes and toe partially obstruct visibility.	
richard_f_20111014_977.jpg

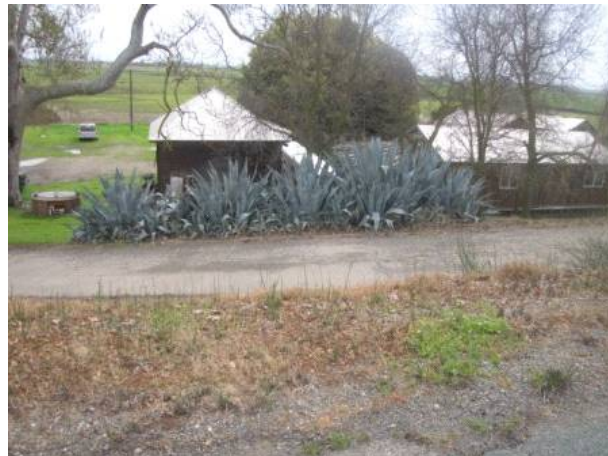
Levee Mile Report Line	45
Start Levee Mile	5.33
End Levee Mile	5.33
Location	Land Side
Category	Earthen Levee
Item	Vegetation
Looking west a century plants on landside slope next to a ramp.	
richard_f_20111014_978.jpg

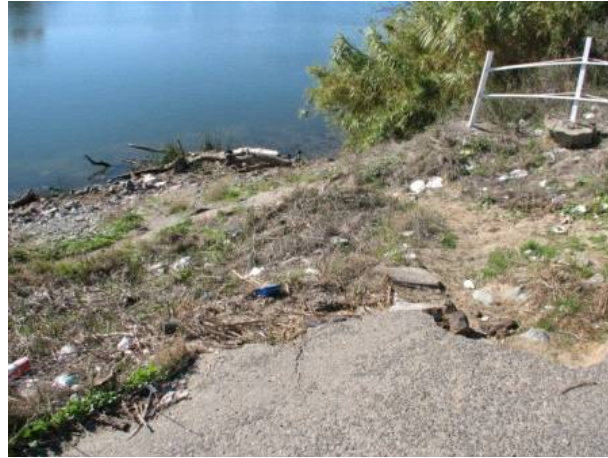
Slope instability caused by foot traffic on levee slope.

5	0.40	0.40	Earthen Levee	Slope Stability	WS	M	Repair the levee slope damaged by foot traffic and prevent access where possible.	38.173989 ° -121.647142 °	38.173989 ° -121.647142 °	1 Y
6	1.32	1.32	Earthen Levee	Encroachments	WS	W	Pipe	38.171005 ° -121.631524 °	38.171005 ° -121.631524 °	39
7	1.71	1.71	Earthen Levee	Encroachments	WS	W	Pipe	38.167958 ° -121.625706 °	38.167958 ° -121.625706 °	40
8	1.93	1.98	Earthen Levee	Encroachments	WS	CO	Landscaping	38.166525 ° -121.622201 °	38.166176 ° -121.621332 °	70 Y
9	2.50	2.50	Earthen Levee	Trim / Thin Trees	LS	W	Trim trees to at least five feet above ground level.	38.164369 ° -121.612548 °	38.164369 ° -121.612548 °	6
10	2.78	2.78	Earthen Levee	Trim / Thin Trees	LS	M	Trim trees to at least five feet above ground level.	38.164676 ° -121.607479 °	38.164676 ° -121.607479 °	951
11	2.91	2.91	Earthen Levee	Encroachments	CR	W	Pipe Inspector Comments: Gas Pipeline	38.165065 ° -121.605275 °	38.165065 ° -121.605275 °	42

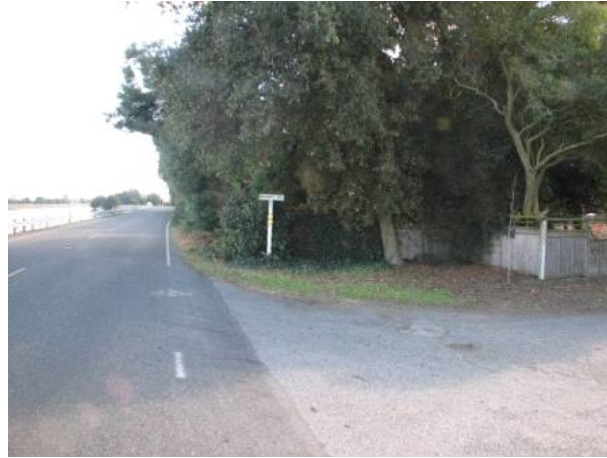
Levee Mile Report Line	75
Start Levee Mile	15.84
End Levee Mile	15.93
Location	Land Side
Category	Earthen Levee
Item	Encroachments
Landscaping on levee slope and toe obstruct access and visibility.	
richard_f_20111014_016.jpg
